Hedges Creek Culvert Crossing

SW Blake & SW 108th Ave Intersection

SW Blake & SW 105th Ave Intersection

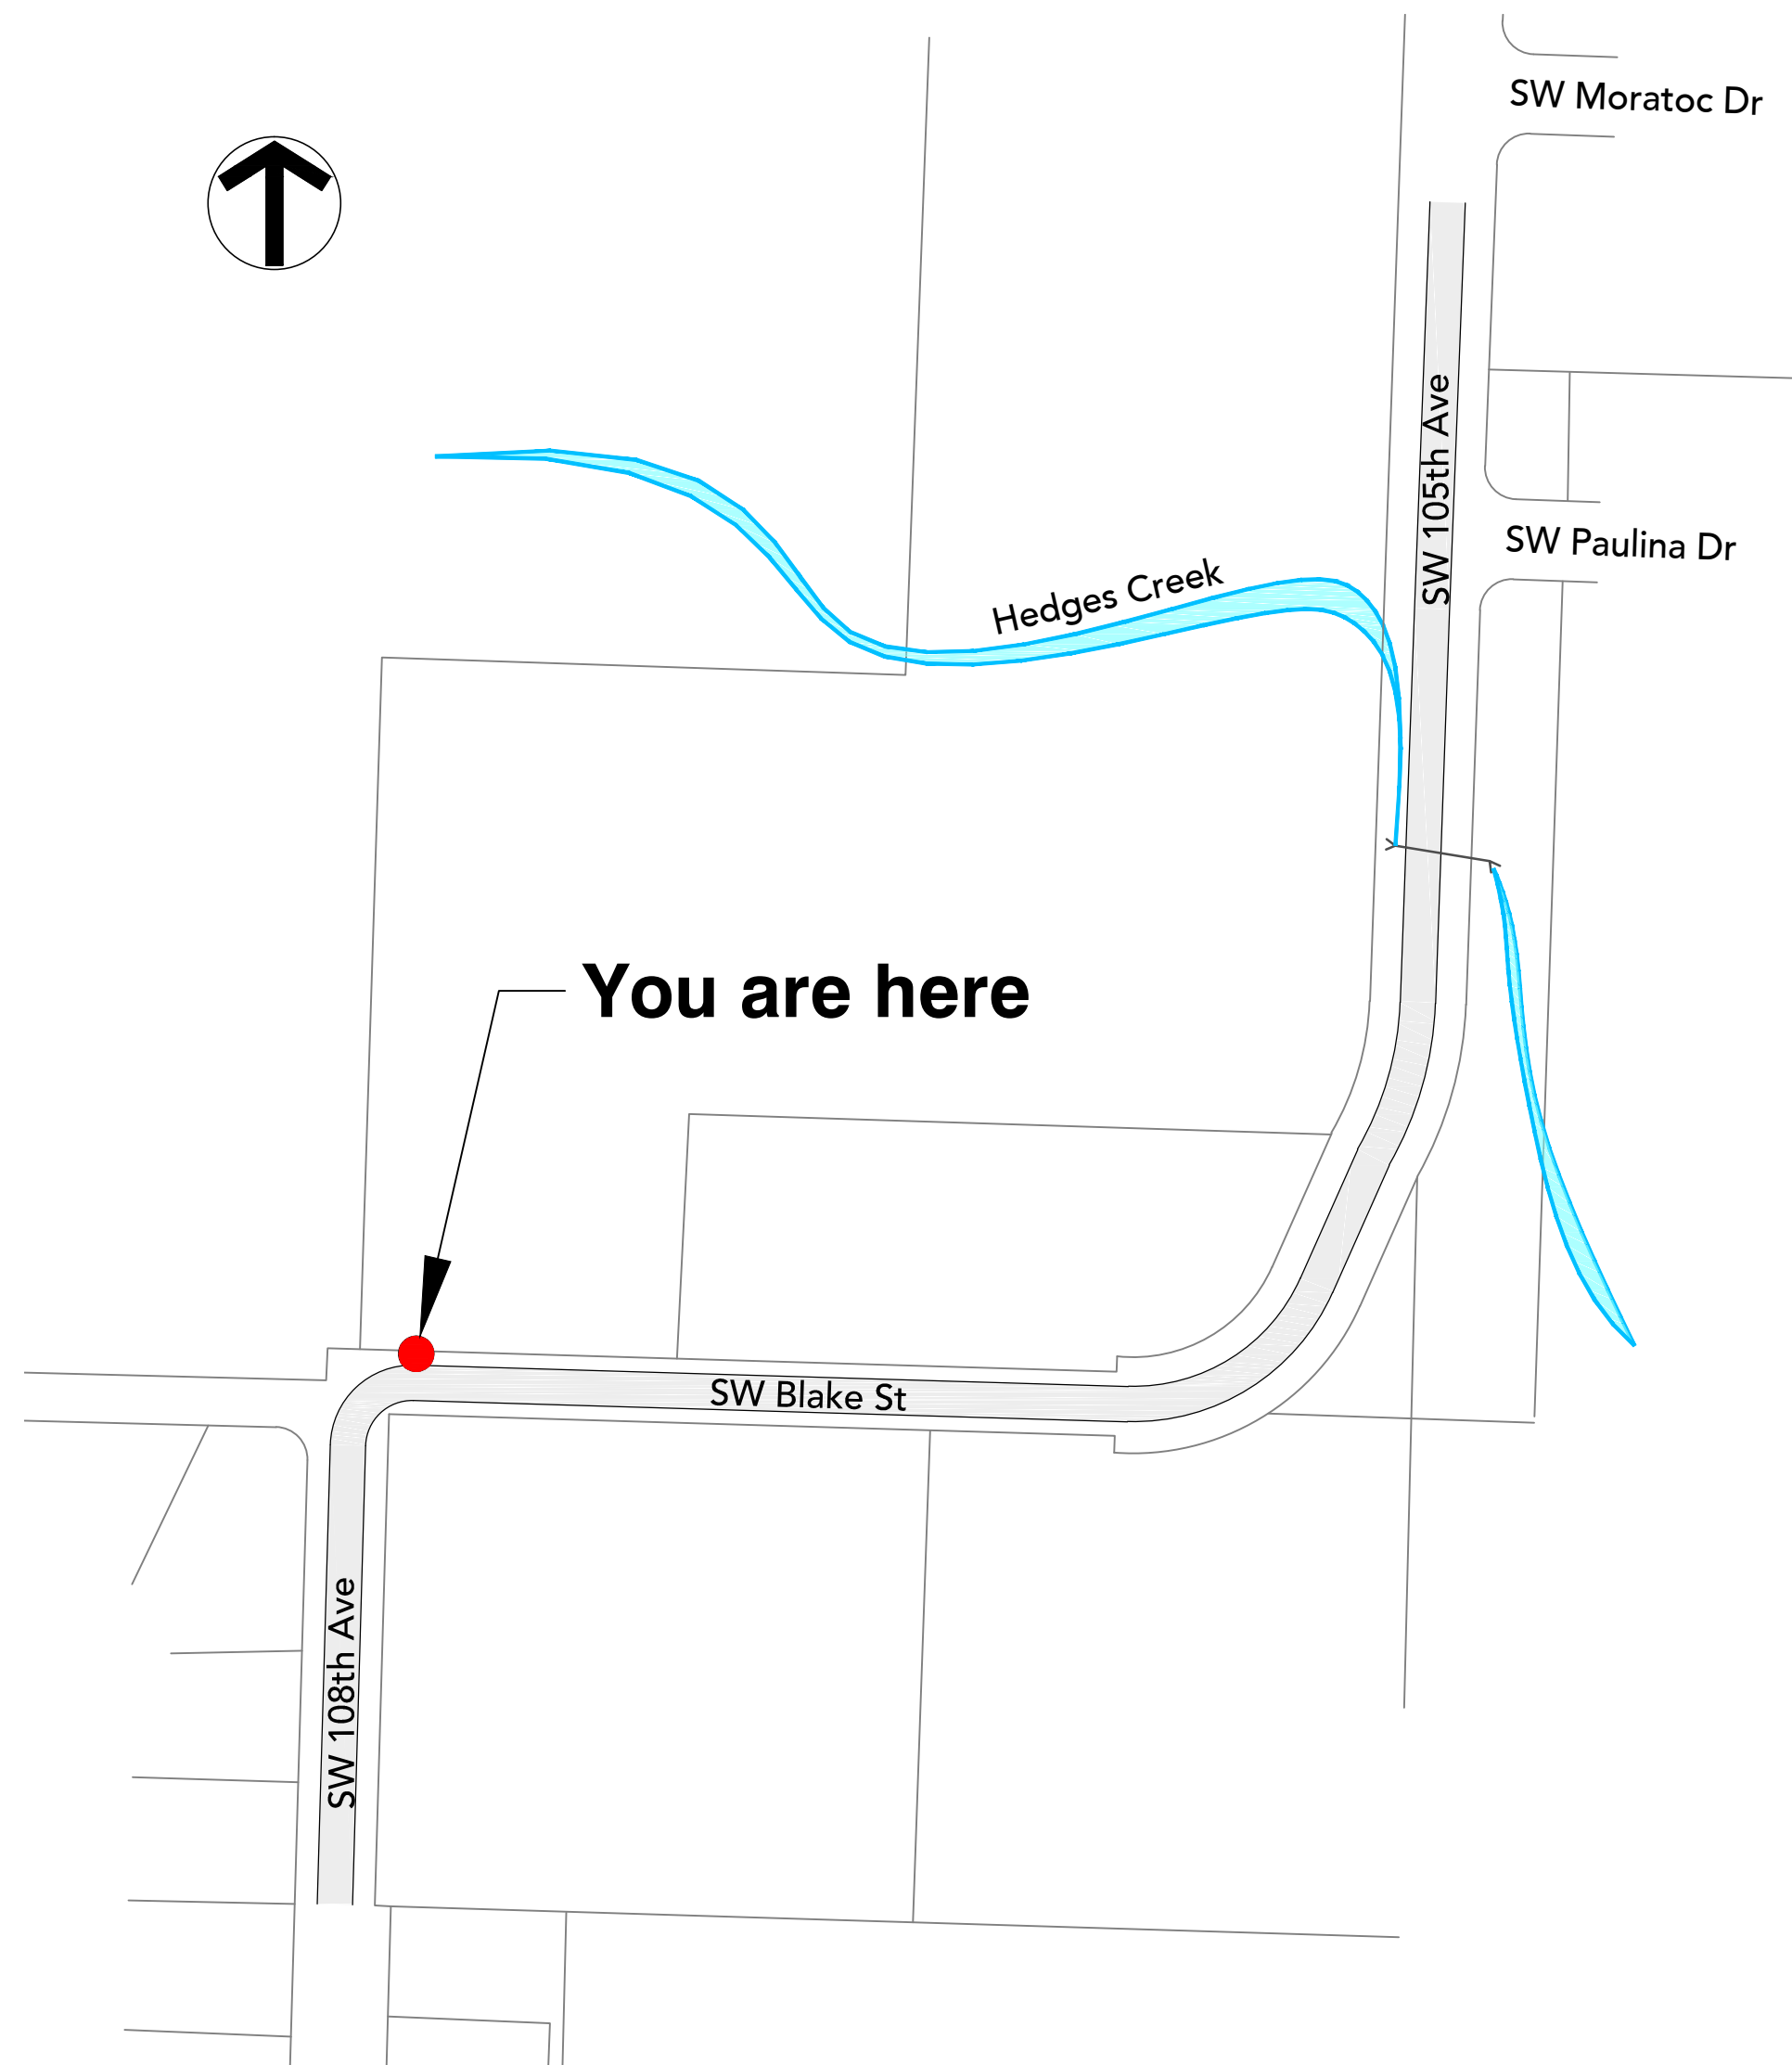
- Significant crash history
- Tight curve with non-standard roadway geometry
- 10 mph advisory speed
- 40-ft wide public Right-of-Way
- Existing wall limits visibility
- Future Helenius Greenway Trail connection
- No sidewalk, no bike lanes
- Limited roadway lighting

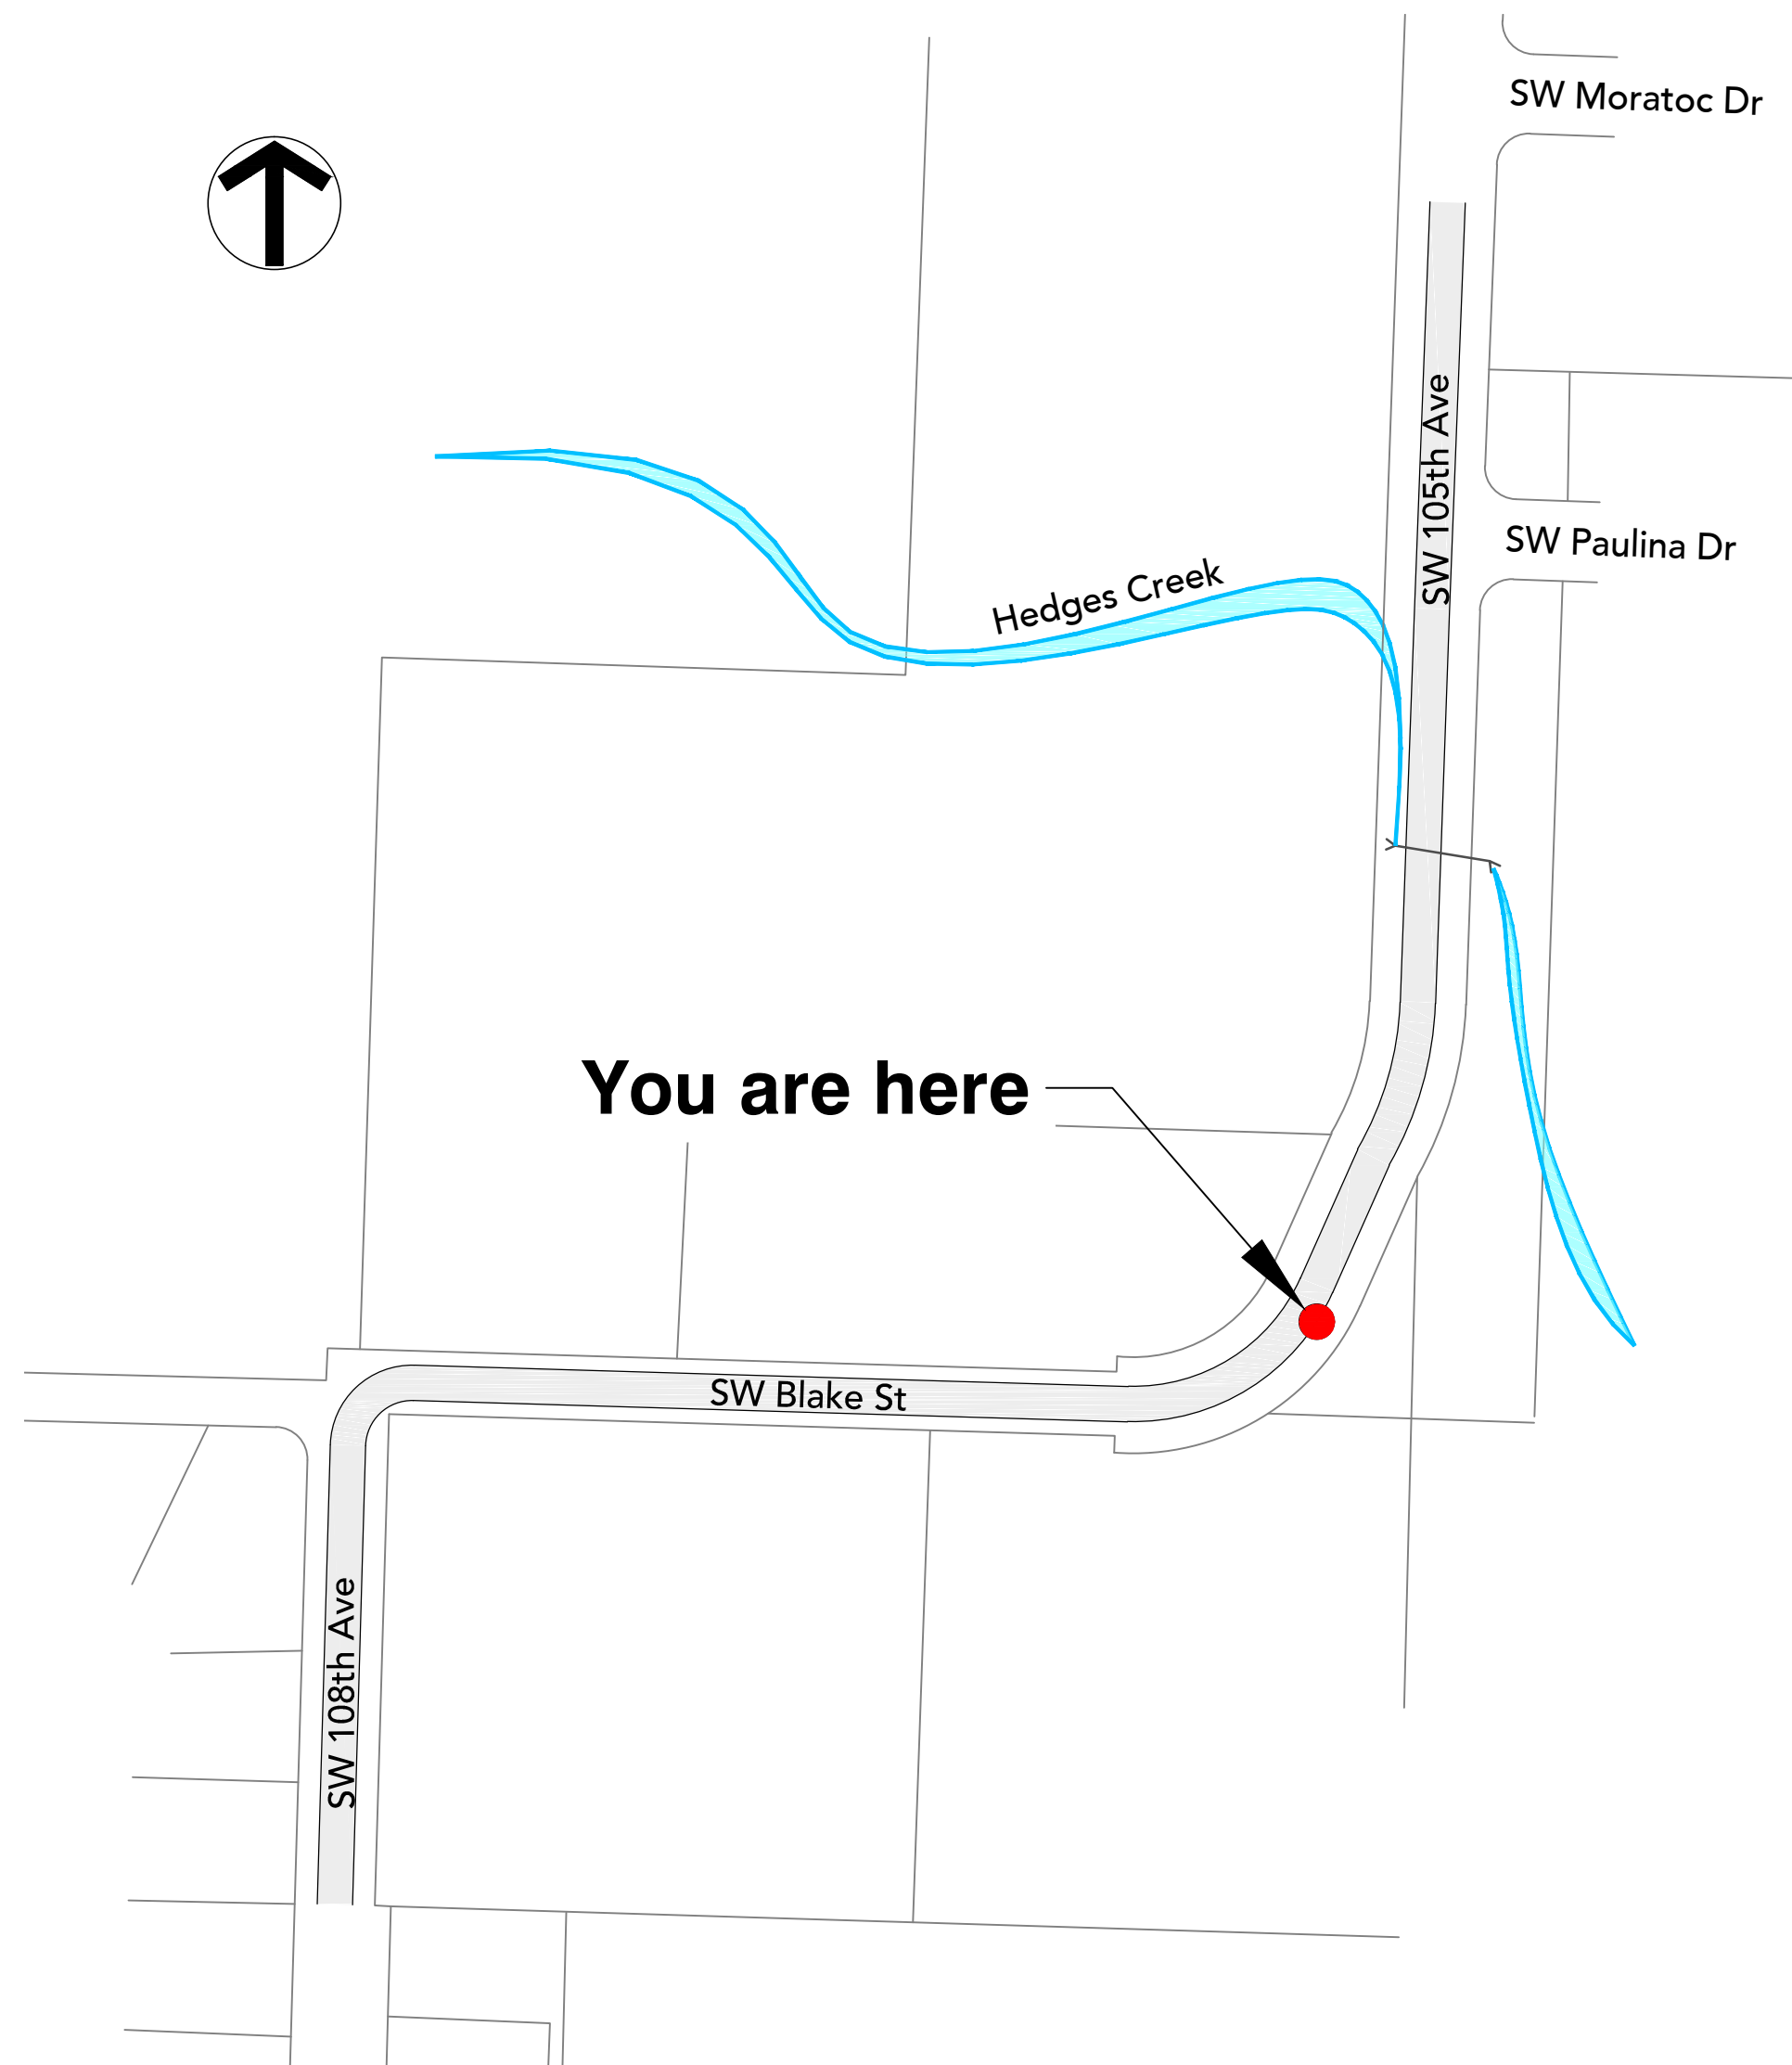
- Tight curve with non-standard roadway geometry
- 15 mph advisory speed
- Limited visibility on inside curve
- Guardrail protects vehicles from steep slopes
- Erosion along road edge
- 60-ft wide public Right-of-Way
- No sidewalk, no bike lanes
- Limited roadway lighting

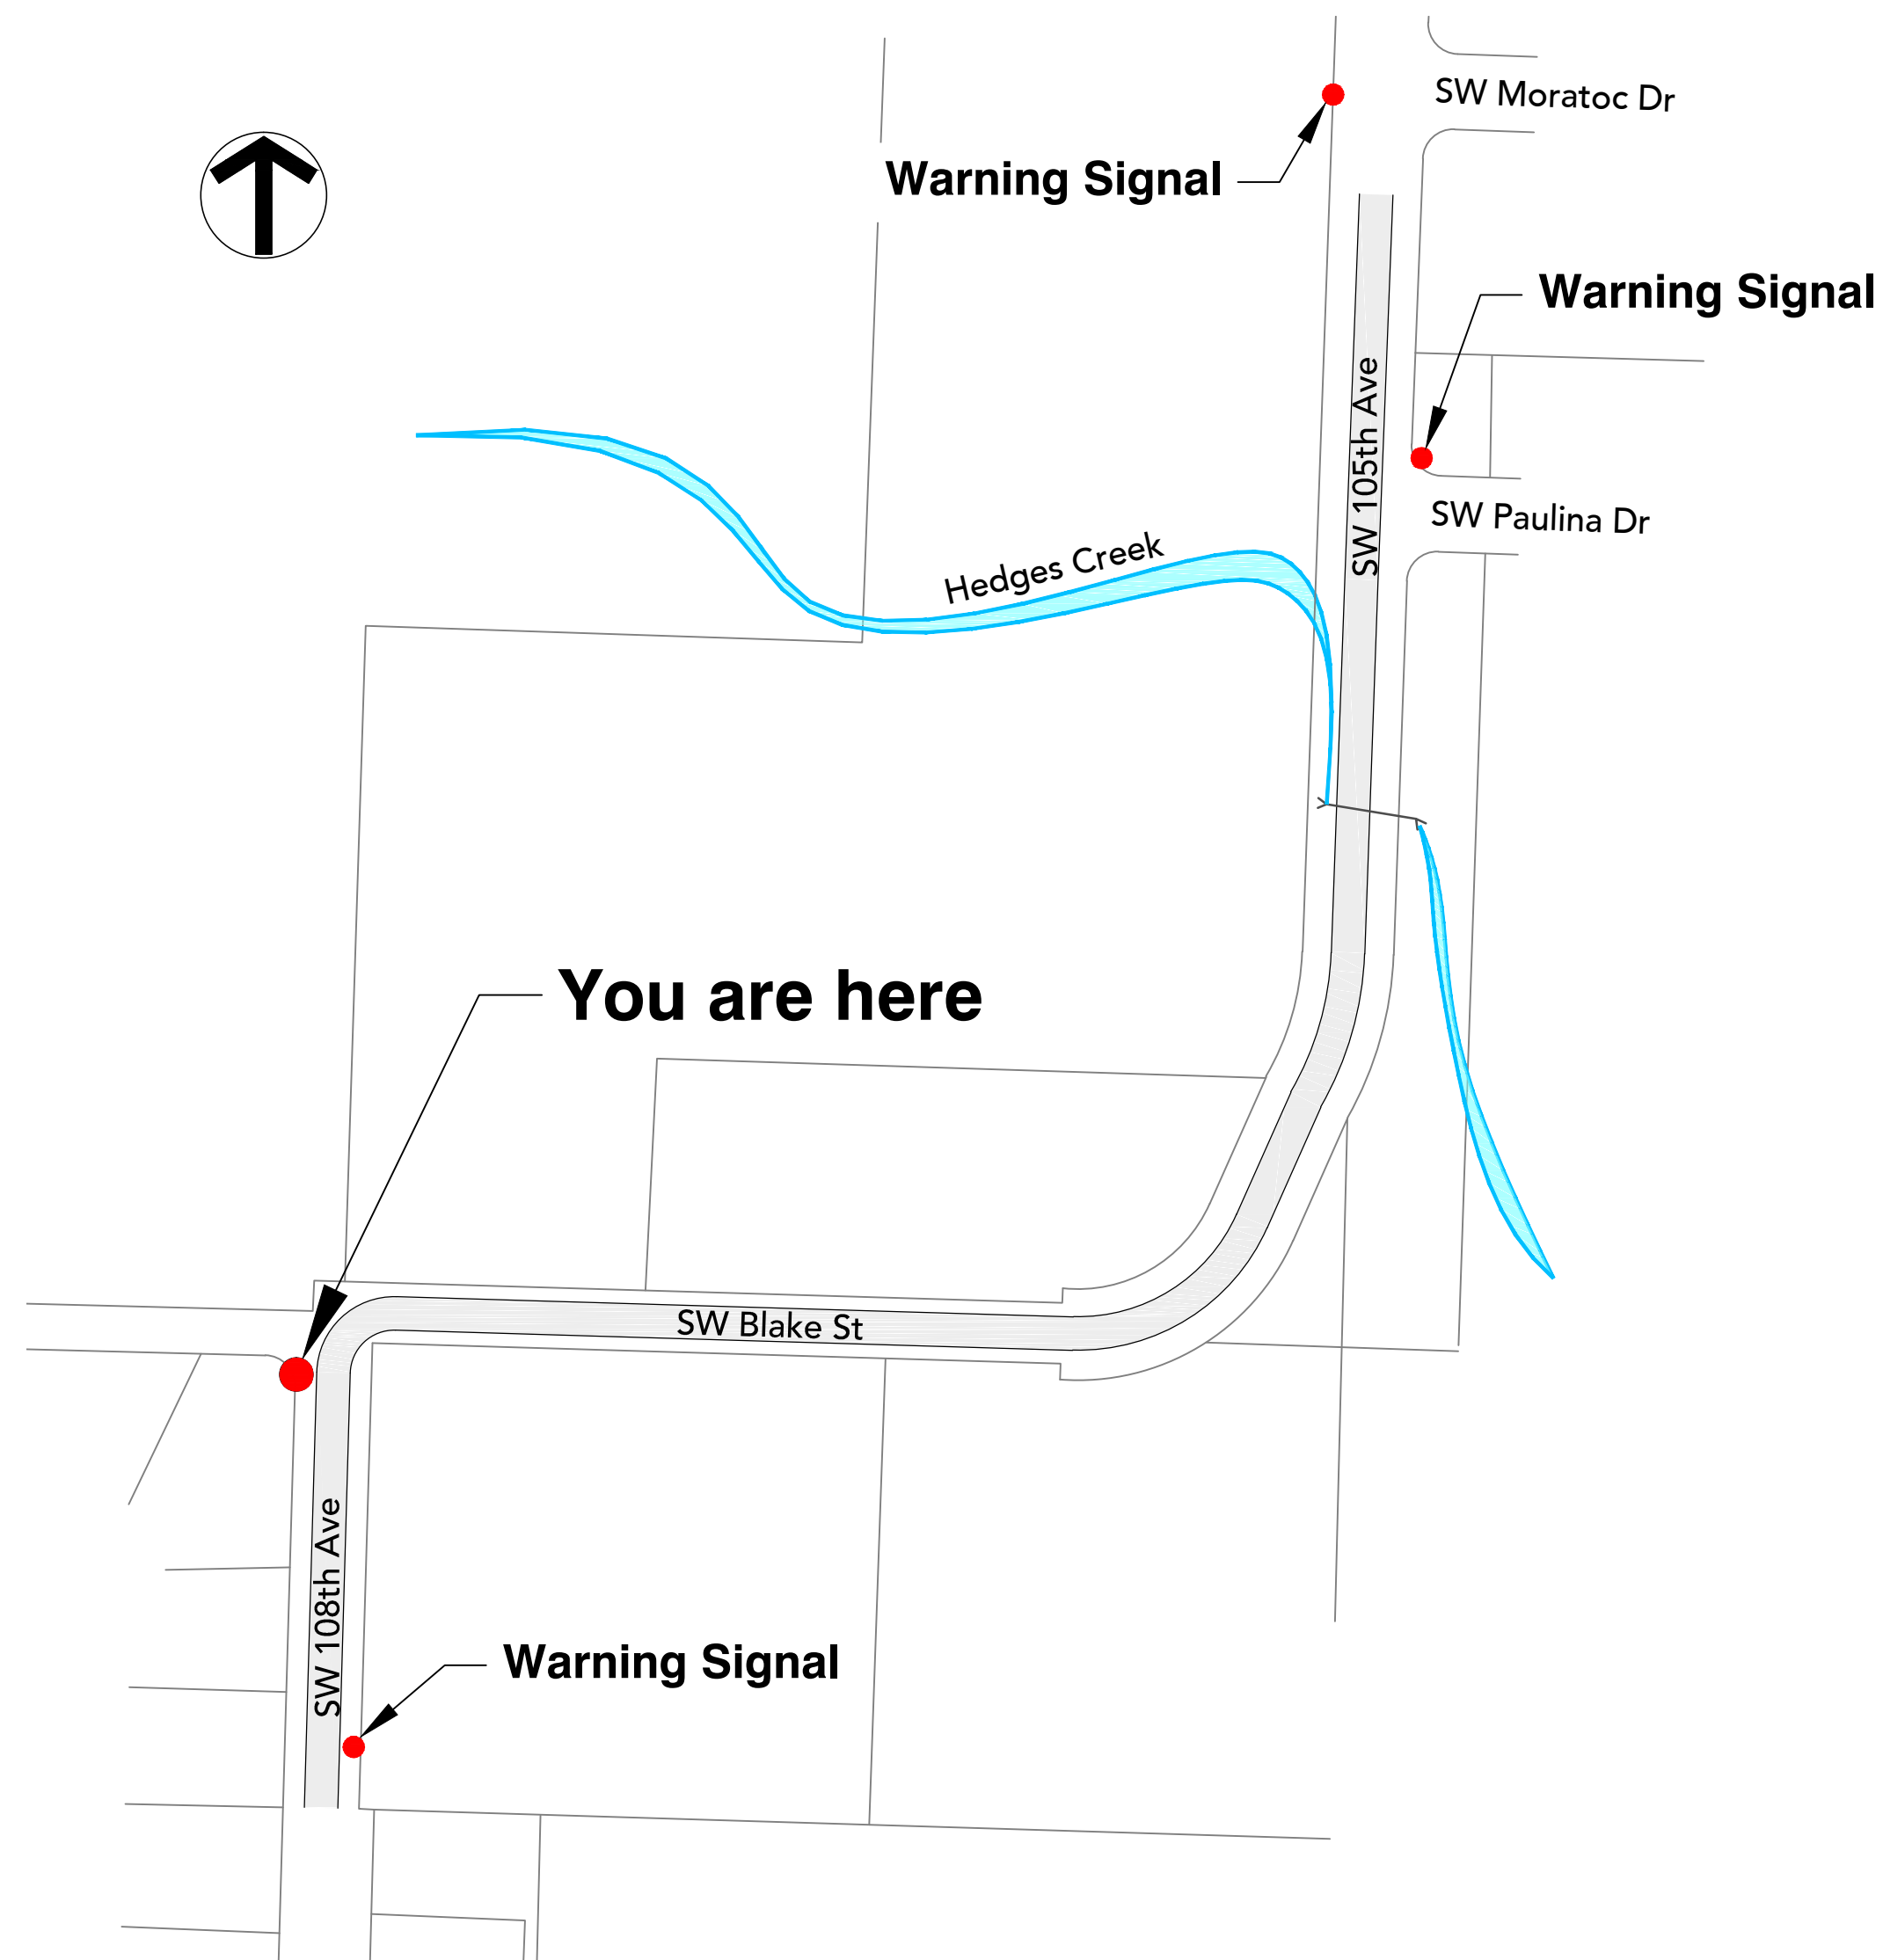
Activated Warning Signal

- Pedestrian and bicyclist activated warning signal
- Installed to address the use of the roadway by pedestrians and bicyclists
- Push the button, and the lights are activated for 10 minutes on the signs at SW 105th Ave and SW 108th Ave
- Installed at the end of sidewalks and bike lanes on SW 105th Ave and SW 108th Ave
- Includes a total of four poles with push buttons to activate the signal

- Signage not well understood
- Lack of driver awareness
- Limited impact on vehicle speeds
- Lack of advance signs, long spacing between signs
- Not ADA compliant
